Fires and BLEVE on LPG tanker lorries

27 July 2010

Port-la-Nouvelle (Aude)

Explosion / BLEVE
Transport of hazardous
materials
Projections
Propane
Mobile storages

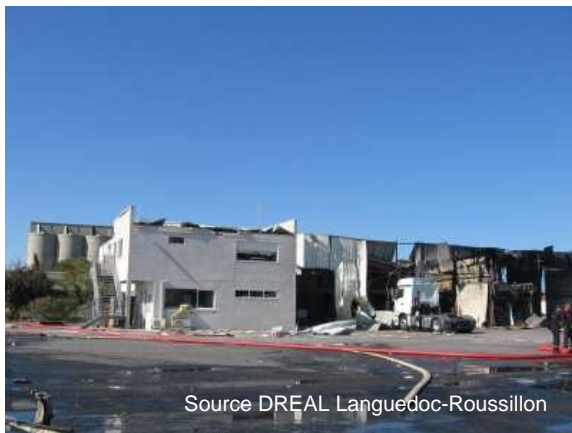
Administrative offices and maintenance shop: concrete structure shifted due to the blast

Pressure effects were reflected by damages of varied intensity to lightweight building structures: cladding, windows, doors, glass panes. Adjacent to the explosion, a concrete wall was also damaged.

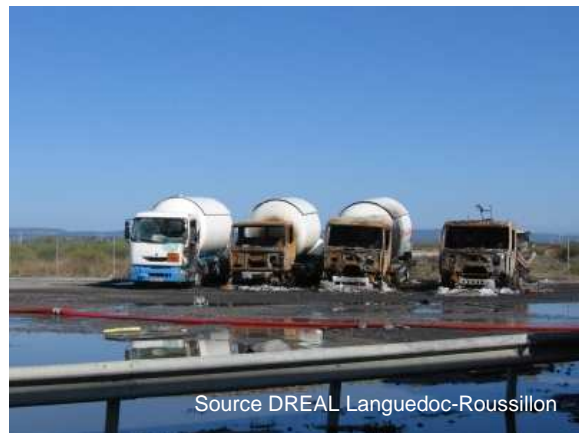
- The 2 empty vehicles dedicated to hydrocarbon transport parked at the targeted zone were destroyed by fire and the walls of their cisterns completely torn apart;
- Among the 8 vehicles for LPG transport, 4 were partially destroyed by the blaze (mainly the cab area, as the cisterns could be spared by spraying water on their walls). Three of these lorries were empty but not yet degassed (displaying a residual pressure of 7 bar), and the fourth was filled with LPG to 82%, under pressure exceeding 7 bar.

Zone occupied by gas tanker vehicles: burned lorries

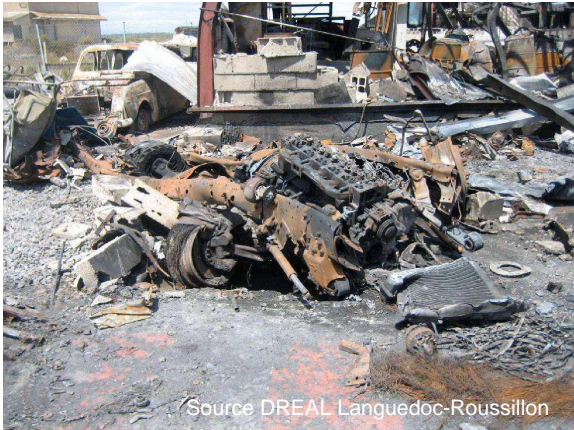
The tanker lorry exposed to this BLEVE was destroyed by both the explosion and fire. The only part remaining on the ground was its engine, as the cistern was found "flattened" on the roof of the repair shop's metal building structure.

Wrecked tanker lorry after exposure to the BLEVE

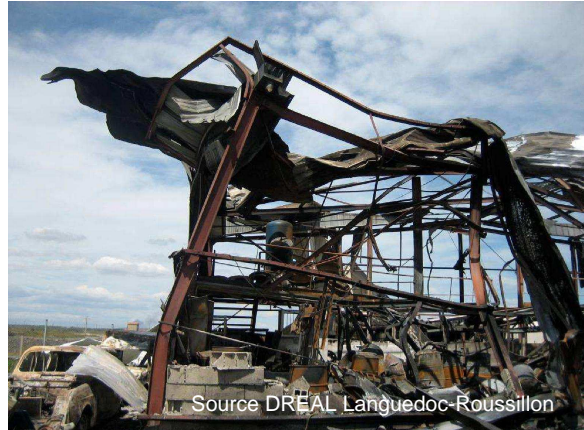
"Flattened" cistern thrown onto a roof

- the largest fragment, comprising most of the shell of the "flattened" cistern, was thrown onto the roof of the repair shop's metal building;
- two pieces were identified outside the site at 20 m and 70 m in front of the lorry, along its alignment;
- a bottom piece (steel flange) was projected in the opposite direction from the previous fragments, beyond the site boundary 150 m from the ignited vehicle.
